# U. S. NAVAL AIR ENGINEERING CENTER

NAEC-ENG-7934

**LONG-TERM WEAR AND IMMERSION TESTS  
OF POLYMERIC COATINGS**

**CONTRACT NO. N68335-76-M-1629**

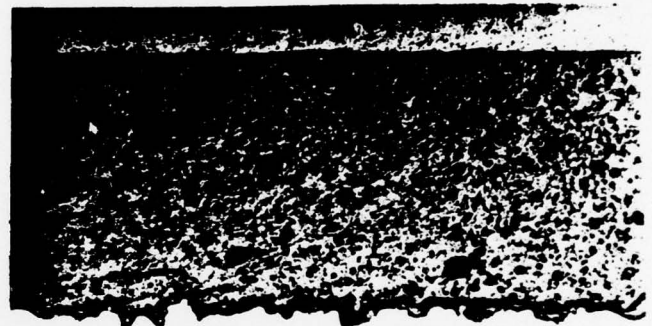
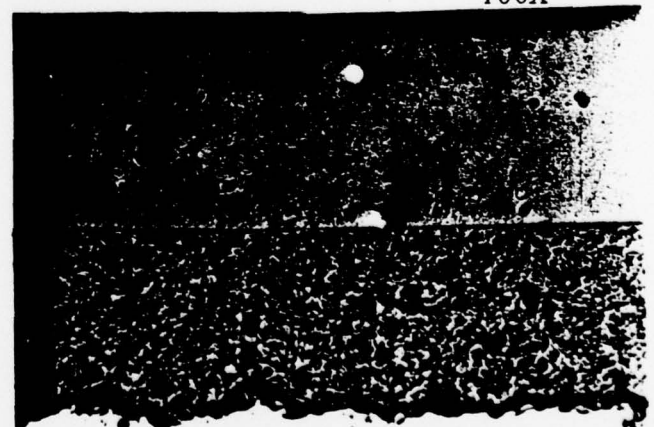
FIGURE 12. SECTIONS OF NYLON 11 IMMERSION SPECIMENS.

3. **Metallographic Examinations.** All of the immersion specimens were sectioned and a piece of each specimen was mounted in plastic for metallographic examination. No blistering, cracking, debonding or other coating deterioration was observed during microscopic examination. Typical sections of each coating are shown in Figures 12-15. It was possible to determine polymeric coating and substrate coating thicknesses by microscopic examination, these data are given in Table VII along with the total substrate plus polymer coating as based on thickness measurements on ground specimens and on coated specimens before the immersion test. Slight differences in total coating thickness as determined by the two techniques are attributed to variations in coating thickness and to metal removed by abrasive blasting of the surfaces before application of the flame-sprayed nickel-aluminide coating (generally around 0.001-in. thick).

(a) Specimen No. 1  
(after immersion test)

Nylon 11 →

Subcoat →

Steel →

(b) Specimen No. 2  
(after immersion test)

(c) Specimen No. 3  
(not tested)

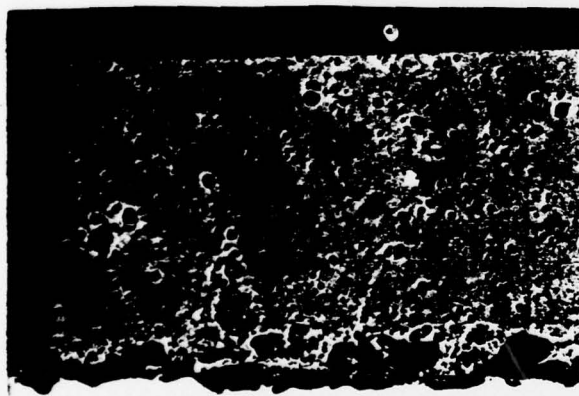
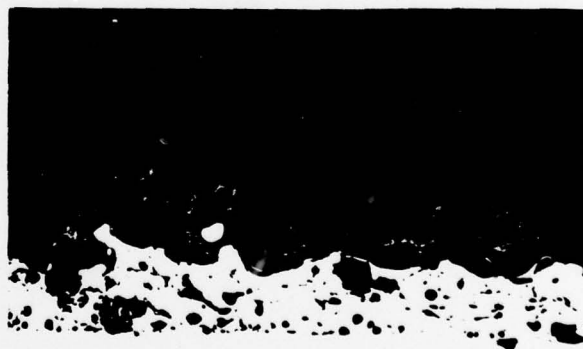
FIGURE 13. SECTIONS OF RYTON P2 IMMERSION SPECIMENS.

Ryton P2

Subcoat

Steel

(a) Specimen No. 10 (after immersion test)

(b) Specimen No. 11 (after immersion test)

(c) Specimen No. 12 (not tested)

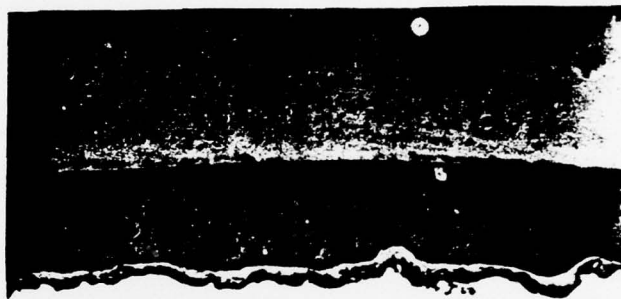
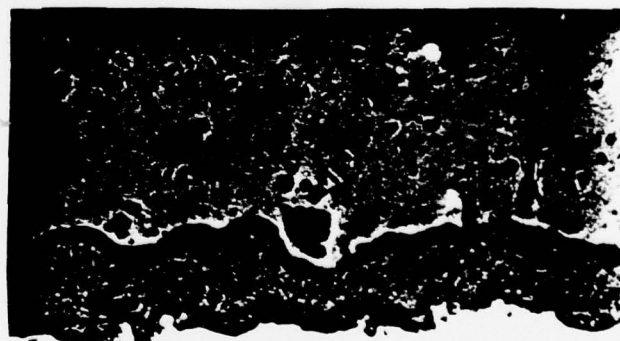
FIGURE 14. SECTIONS OF LNP-ETF-2001 IMMERSION SPECIMENS.

(a) Specimen No. 4  
(after immersion test)

LNP-ETF-2001 →

: Subcoat →

Steel →

(b) Specimen No. 5  
(after immersion test)

(c) Specimen No. 6  
(not tested)

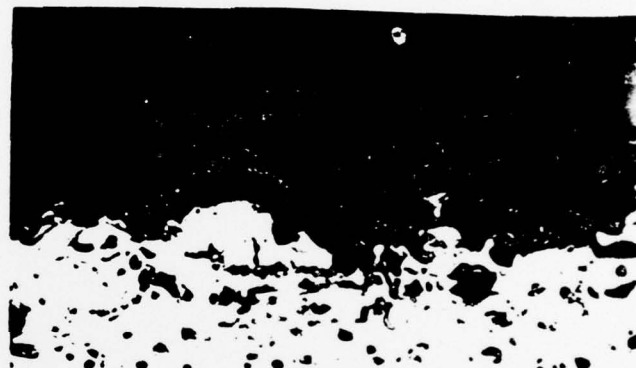
FIGURE 15. SECTIONS OF URETHANE 3699 IMMERSION SPECIMENS.

(a) Specimen No. 7  
(after immersion test)

Urethane 3699 —————→

Subcoat —————→

Steel —————→

(b) Specimen No. 8  
(after immersion test)

(c) Specimen No. 9  
(not tested)
